Manhole Inspection Summary

Manhole # S41AA_078MH

Insp Date: **11/28/07 12:11 PM**

Location Address: **1318 e.monument st**

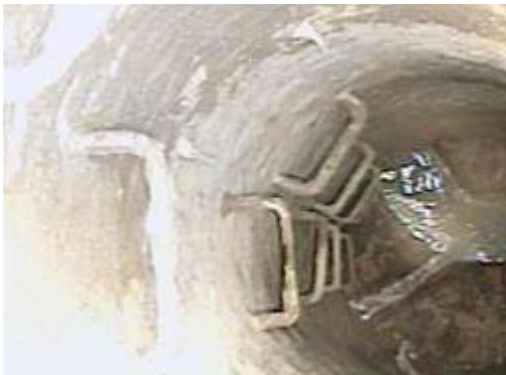
Defect 1

Count: **11** Missing: **1** ☒ **Corroded**

missing/corroded steps

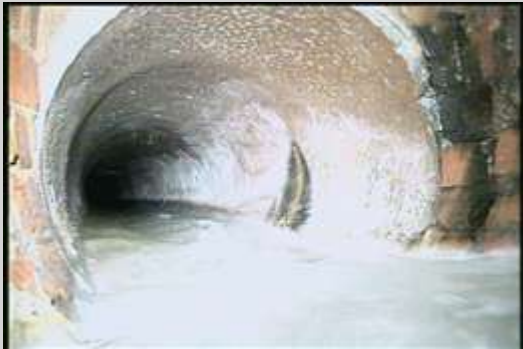
12 O'Clock Outflow

18 in. Circular Gravity Sewer
Pipe Out @ 12 O'Clock

Pipe Material: **Clay** ☐ Pipe Lined

Invert Depth: 17.40 (ft.) Flow Characteristics: **Fast**

Deposits: ☒ None ☐ Mud ☐ Sludge ☐ Debris ☐ Grease

Infiltration: **None** Pipe Seal Cond: **Unknown**

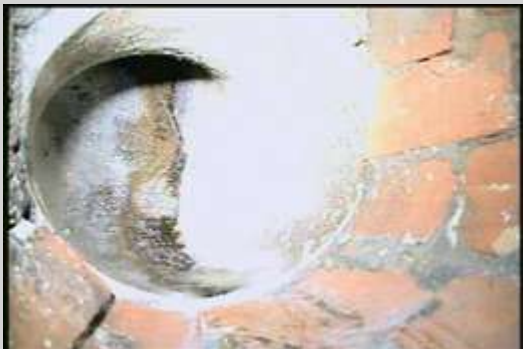
3 O'Clock Inflow

8 in. Circular Gravity Sewer
Pipe In @ 3 O'Clock

Pipe Material: **Clay** ☐ Pipe Lined

Invert Depth: 16.50 (ft.) Flow Characteristics: **Slow**

Deposits: ☒ None ☐ Mud ☐ Sludge ☐ Debris ☐ Grease

Infiltration: **None** Pipe Seal Cond: **Unknown**

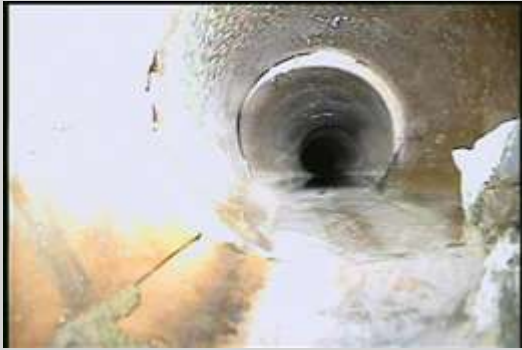
6 O'Clock Inflow

8 in. Circular Gravity Sewer

Pipe In @ 6 O'Clock

Pipe Material: **Clay** ☐ Pipe Lined

Invert Depth: **17.10** (ft.) Flow Characteristics: **Slow**

Deposits: ☒ None ☐ Mud ☐ Sludge ☐ Debris ☐ Grease

Infiltration: **None** Pipe Seal Cond: **Unknown**

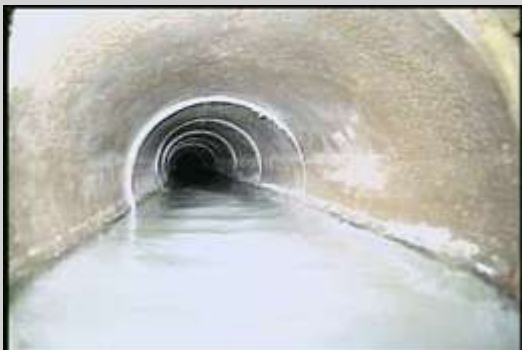
9 O'Clock Inflow

18 in. Circular Gravity Sewer

Pipe In @ 9 O'Clock

Pipe Material: **Clay** ☐ Pipe Lined

Invert Depth: **17.25** (ft.) Flow Characteristics: **Fast**

Deposits: ☒ None ☐ Mud ☐ Sludge ☐ Debris ☐ Grease

Infiltration: **None** Pipe Seal Cond: **Unknown**
